## 4.1 INTRODUCTION

## 4.2 INTERSECTION LEVELS OF SERVICE (MOTORIZED)

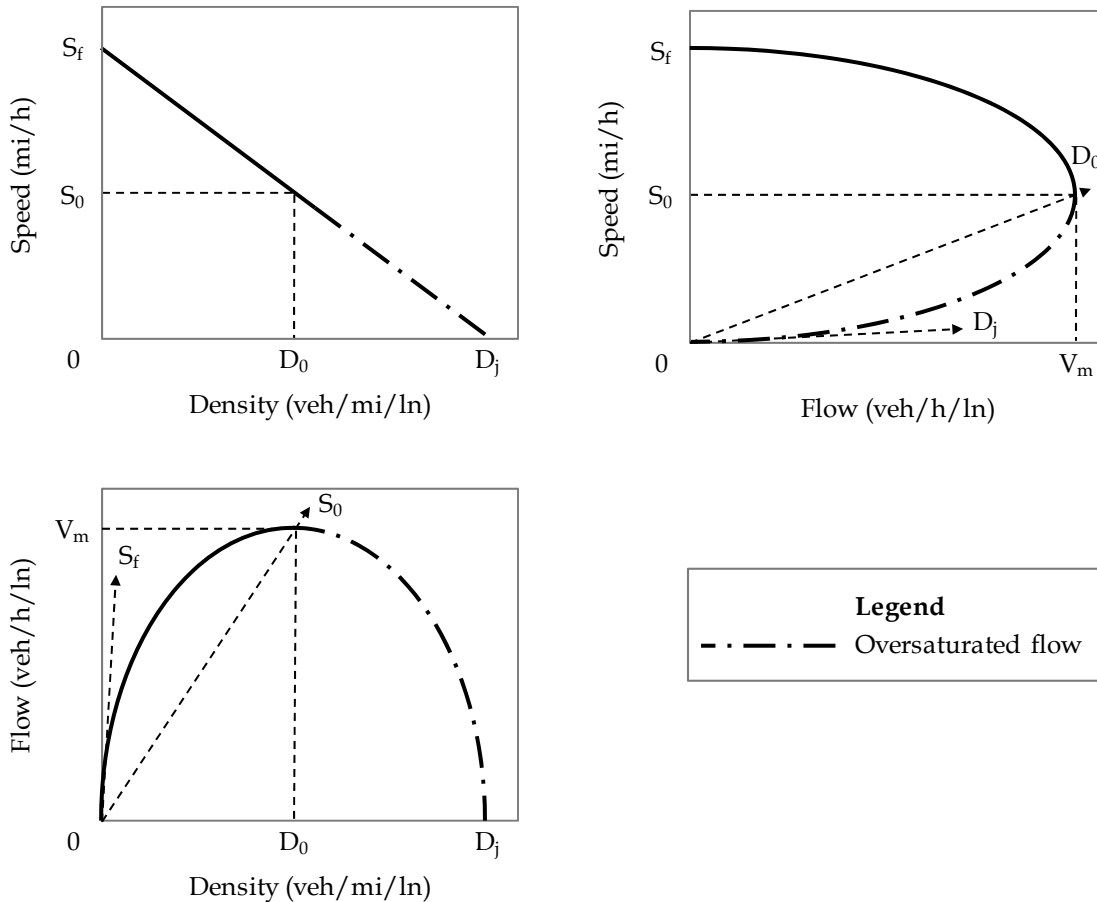
**Figure 4-1** shows a generalized relationship between these three variables (as defined by the above equation). The form of these functions depends on the prevailing traffic and roadway conditions on the segment under study and on its length in determining density. Although these diagrams show continuous curves, it is unlikely that the full range of the functions would appear at any particular location.

Between these two points, the dynamics of traffic flow produce a maximizing effect. As flow increases from zero, density also increases, since more vehicles are on the roadway. When this happens, speed declines because of the interaction of vehicles. This decline is negligible at low and medium densities and flow rates. As density increases, these generalized curves suggest that speed decreases significantly before capacity is achieved. **Capacity** is reached when the product of density and speed results in the maximum flow rate. This condition is shown as optimum speed, optimum density, and maximum flow.

Any flow other than capacity can occur under two different conditions, one with a high speed and low density and the other with high density and low speed. LOS A through E are defined on the low-density, high-speed side of the curves, with the maximum-flow boundary of LOS E placed at capacity. LOS F describes oversaturated flow and is represented by the high-density, low-speed part of the functions.

**Figure 4-1**  
**Fundamental Relationships between Speed-Density-Flow (May 1990)**
