Absaroka Abatement LLC

LIMITED ASBESTOS SURVEY

Gallatin County Law and Justice Center

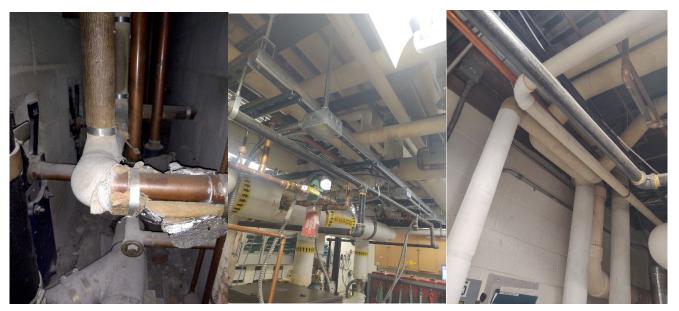
Tsi pipe insulation

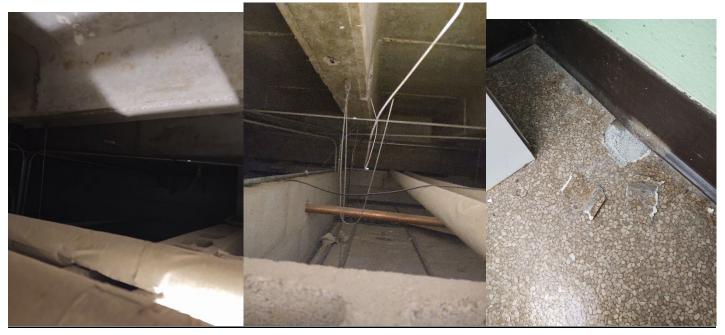
ACM Sheet flooring in Morgue

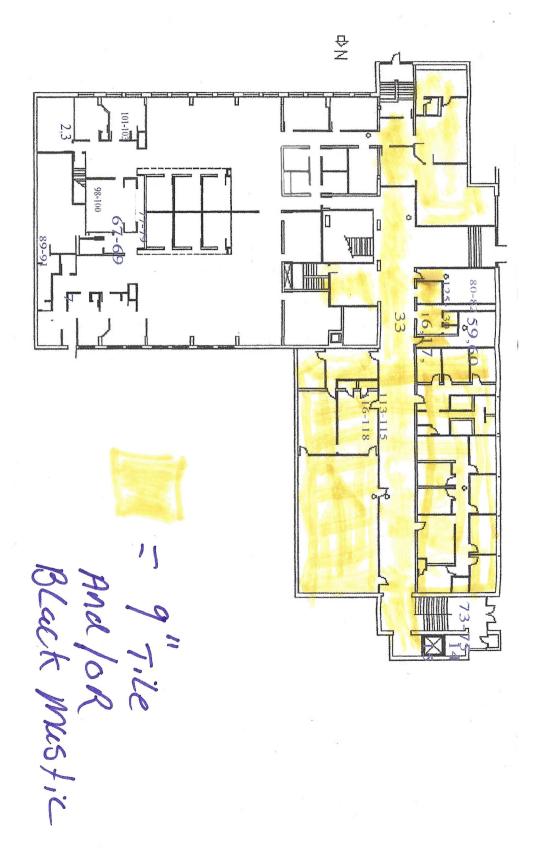
Seamless Flooking ACM Law & Justice Center Floor Three 18,19,20, 21,34,35 57,58 104-106 26-29 IYL タN 54-56 13 119-124 61-63 36-38
